Manhole Inspection Summary

Manhole # S21WW1001MH

Location Address: **HAMLET HILL CT**

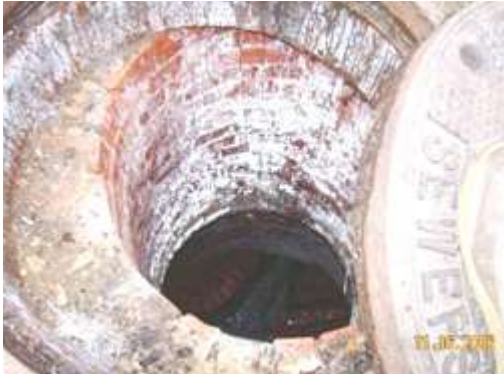
Defect

Frame Offset: **6** (in.) Condition: ☒ Sound ☐ Cracked ☐ Leaks

Condition: ☐ Sound ☐ Cracked ☐ Root Intrusion ☐ Loose Brick ☒ **Deteriorated**

Infiltration: ☐ None ☒ **Joint** ☐ Cracks ☒ **Mortar** ☐ Roots ☐ Wall

Frame offset. Adjustment deterioration and infiltration.

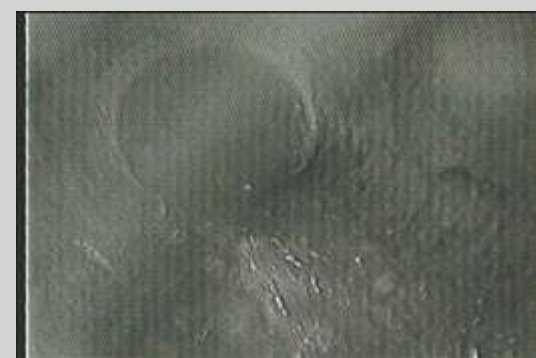
8 in. Circular Gravity Sewer Pipe Out @ 12 O'Clock

Infiltration: **None** Pipe Seal Cond: **Cracked**

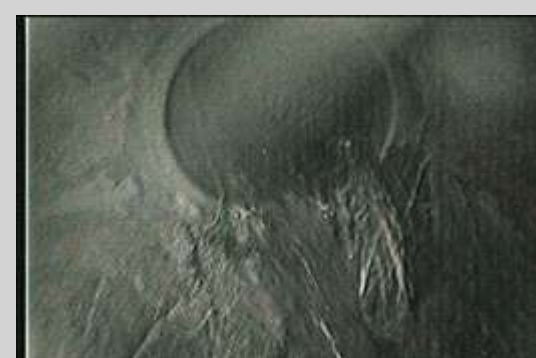
8 in. Circular Gravity Sewer Pipe In @ 3 O'Clock

Condition: ☐ Sound ☐ Cracked ☒ **Root Intrusion** ☒ **Deteriorated** ☐ Leaks ☐ Debris

Channel root intrusion.

Infiltration: **None** Pipe Seal Cond: **Roots**

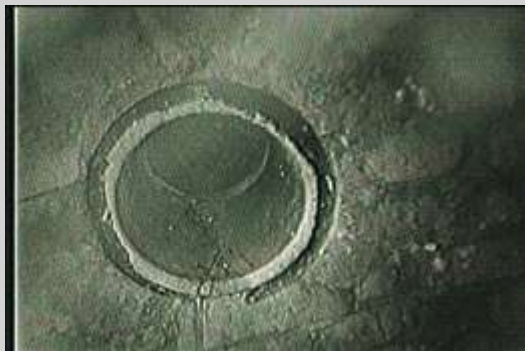
6 in. Circular Gravity Sewer

Infiltration: **None** Pipe Seal Cond: **Cracked**

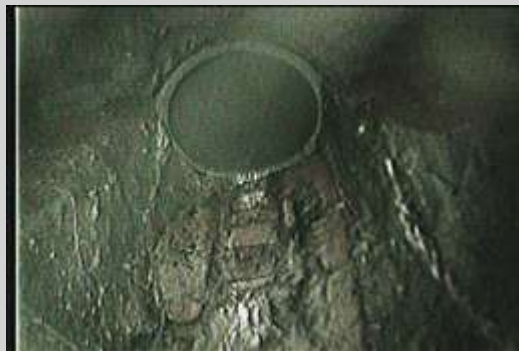
Drop In @ 5 O'Clock

Channel deterioration.

Drop Condition: **Open**

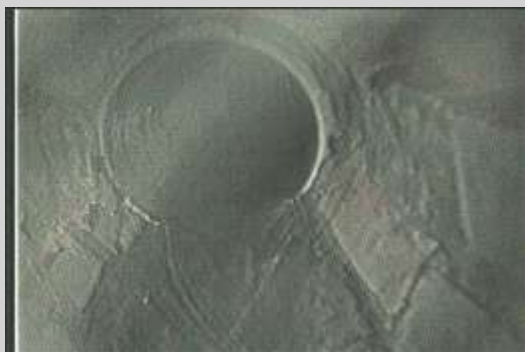
8 in. Circular Gravity Sewer

Infiltration: **None** Pipe Seal Cond: **Unknown**
